**SFPE Expert middag Brandveilige Houten Gebouwen**  
***Real Scale Fire Tests***

**Dr. Daniel Brandon**

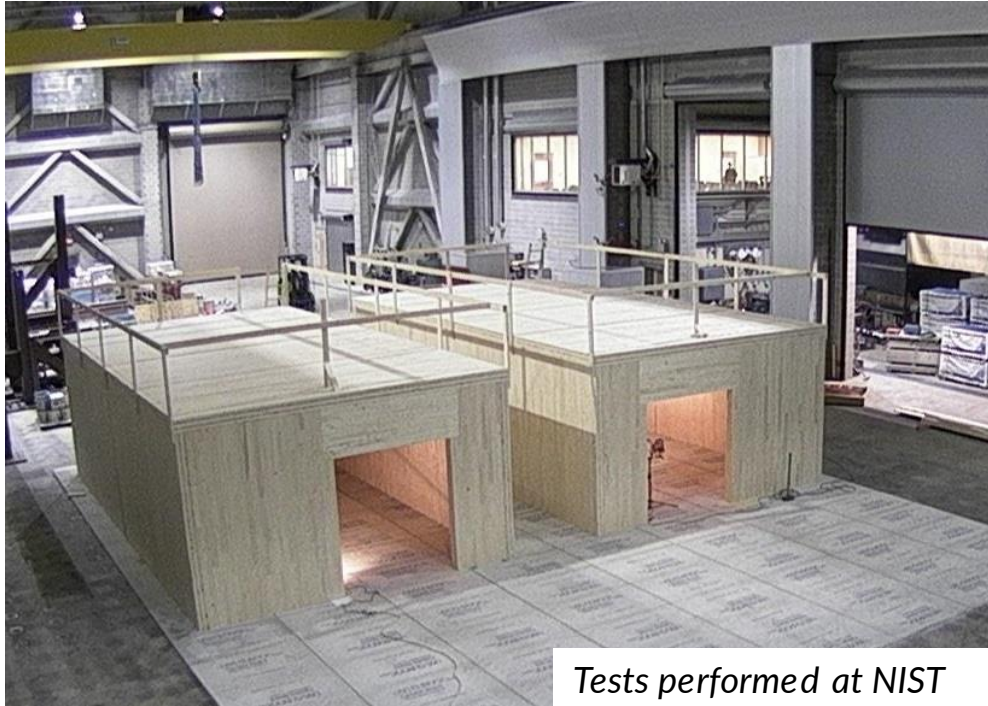
- Number of tests: 6
- Compartment dimensions:  
9.2 x 4.6 x 2.7 m
- 175mm, 5-ply CLT  
35-35-35-35-35 mm
- Fuel load density:  
550 MJ/m<sup>2</sup> (Above residential average in  
Canada)

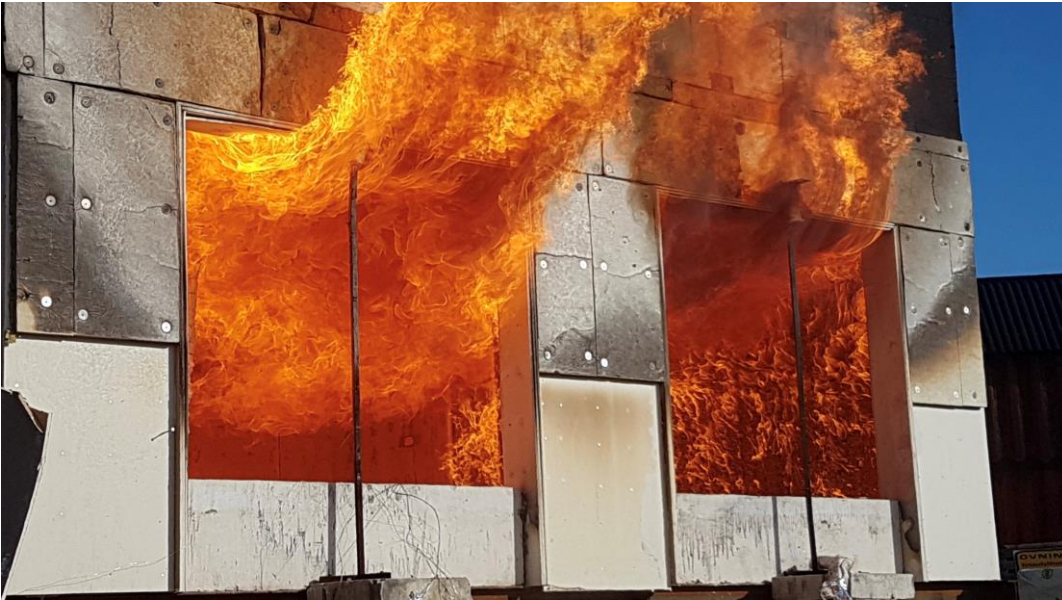
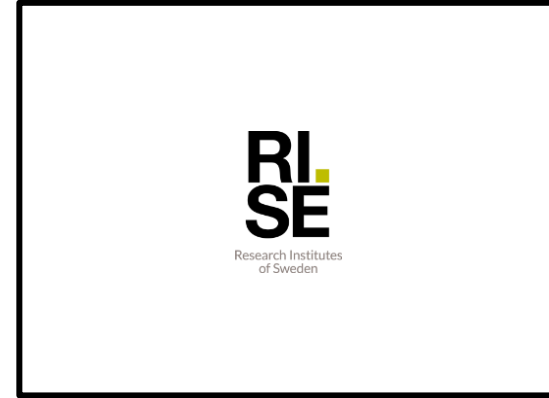
## Fire Safe Implementation of Visible Mass Timber in Tall Buildings

- Number of tests: 5
- Compartment dimensions:  
7.0 x 6.9 x 2.7 m
- 175mm, 5-ply CLT  
35-35-35-35-35 mm
- Fuel load density:  
560 MJ/m<sup>2</sup>  
(Above residential average in Canada)

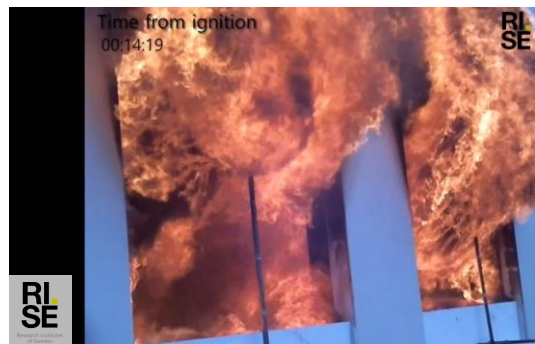
Test 1 - Exposed timber: 53.8 m<sup>2</sup>

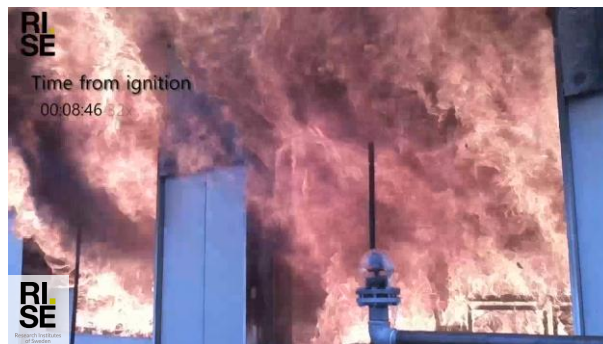
Test 2 - Exposed timber: 91.2 m<sup>2</sup>

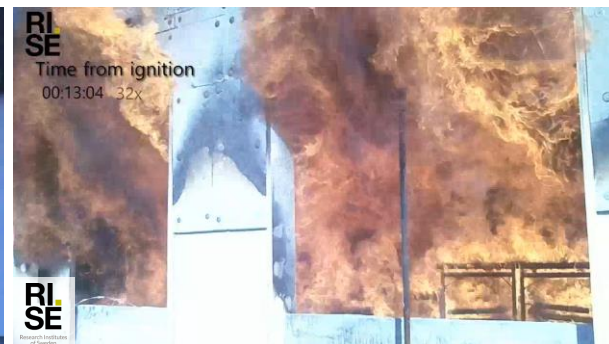
Test 3 - Exposed timber: 96.2 m<sup>2</sup>

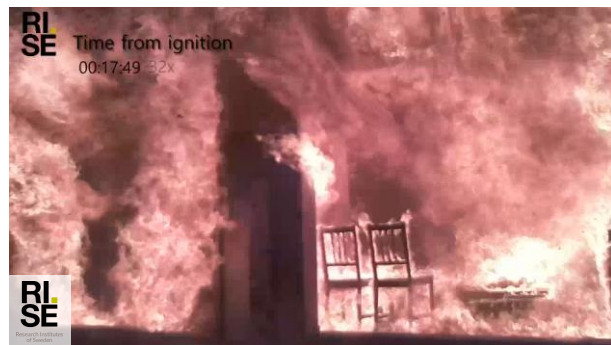
Test 4 - Exposed timber: 77.9 m<sup>2</sup>

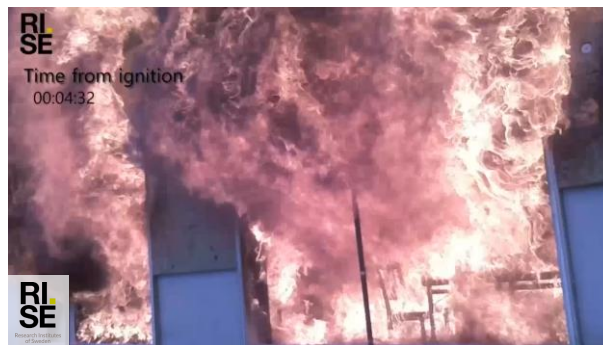
Test 5 - Exposed timber: 97.2 m<sup>2</sup>

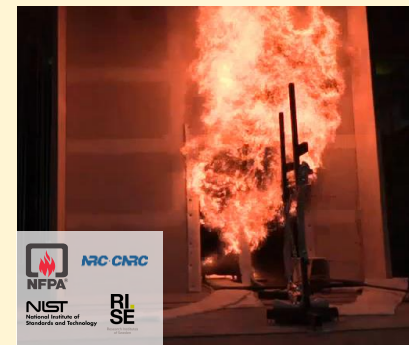
Reference without PRG320(2018)  
compliance - Exposed: 67 m<sup>2</sup>

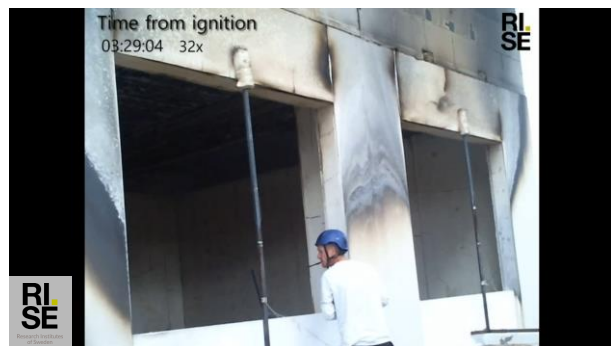
Test 1 - Exposed timber: 53.8 m<sup>2</sup>

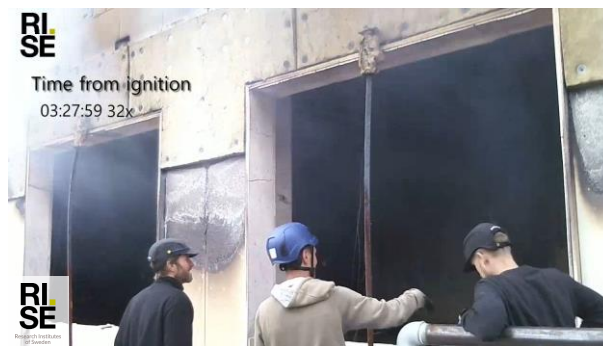
Test 2 - Exposed timber: 91.2 m<sup>2</sup>

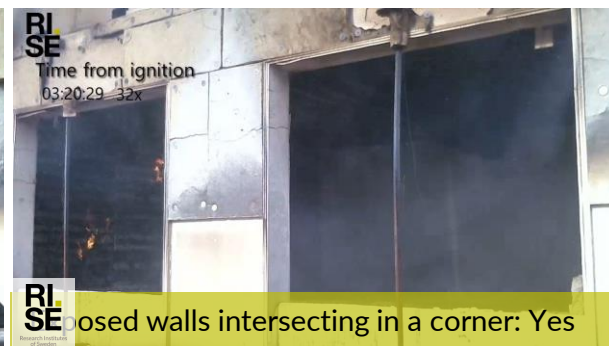
Test 3 - Exposed timber: 96.2 m<sup>2</sup>

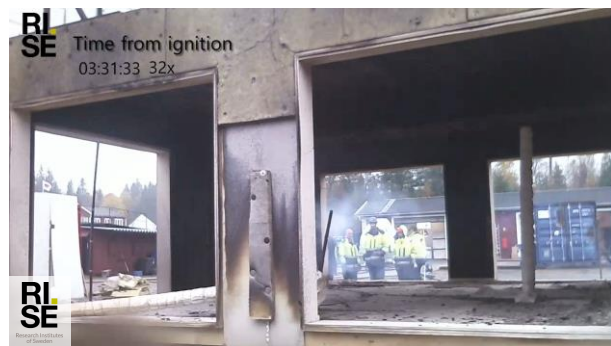
Test 4 - Exposed timber: 77.9 m<sup>2</sup>

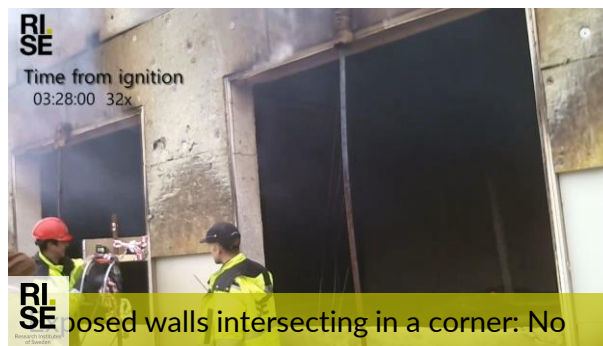
Test 5 - Exposed timber: 97.2 m<sup>2</sup>

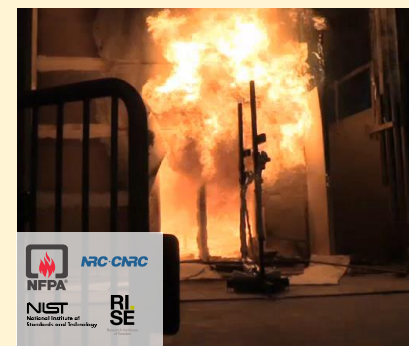
Reference without PRG320(2018)  
compliance - Exposed: 67 m<sup>2</sup>
